# New York State Department of Transportation

## Yellow Flag NB2358W011

### Structure Information

**BIN: 1065318**

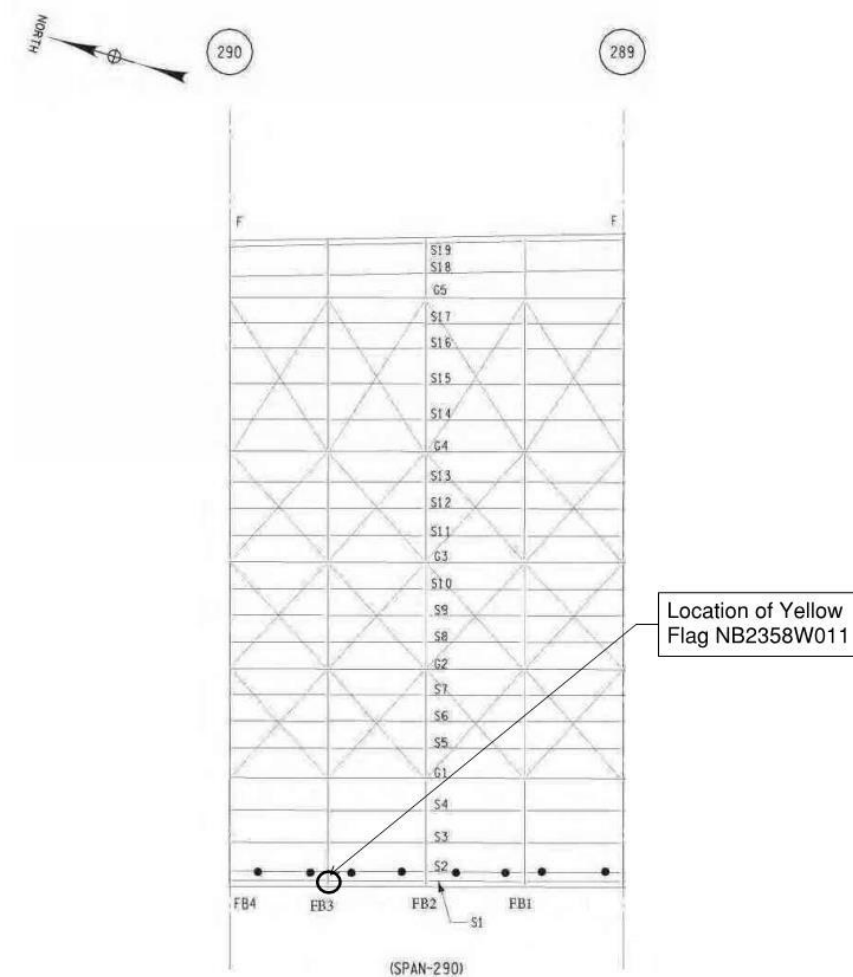
**Flag Photographs**Photo Number: **1**Photo Filename: **23\_Flag Location Plan.jpg**Gowanus Expressway  
2023 Biennial Inspection - Field SketchBIN: 1065318Team: AA/TSDate: 05/05/2023Span: 290Location: Stringer S1 at Floorbeam FB3**Yellow Flag Location Plan**

Location: Span 290, Stringer S1 at end side of Floorbeam FB3 above the center lane of Hamilton Avenue WB roadway near 15th Street.

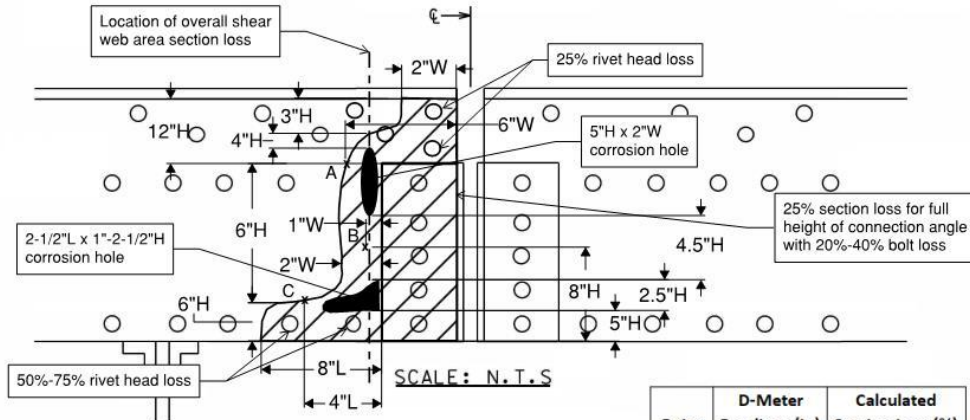
Photo Number: 2

The end of Stringer S1 in Span 290 at the end side of Floorbeam FB3 exhibits severe section loss for the full height of the web along the connection angle with 0.12"-0.25" remaining thickness measured (RTM), resulting in approximately 38% to 70% section loss with average 54% section loss for full stringer web height. The stringer web exhibits two corrosion holes adjacent to the connection angle for 5"H x 2"W in the upper web and 2-1/2"L x 1"-2-1/2"H in the lower web. The overall shear web area section loss is approximately 61%. Four rivets at the left face of the stringer exhibits section loss for 25% in two rivets at the upper web and 50%-75% in two rivets in the lower web. Two rivets at the right face of the stringer exhibits 25% section loss in the lower web. The right side bottom flange exhibits 10"L x 3"W corrosion hole at the edge of the flange with 30% section loss surrounding the hole followed by 20% section loss for the full width of the flange for 12" long. The left connection angle exhibits 25% section loss for full height of connection angle with 20%-40% bolt loss. The right connection angle exhibits no significant defects. (refer to Flag Condition Sketch Photo #2 for more details)

**Overall Shear Web Area Section Loss:**

$$5" \times 0.25" [\text{Point C}] + 2.5" \times 0" [\text{Corrosion hole}] + 4.5" \times 0.18" [\text{Point B}] + 5" \times 0" [\text{Corrosion hole}] + 4" \times 0.12" [\text{Point A}] + 3" \times 0.40" = 3.74 \text{ in}^2$$

$$((24" \times 0.40") - 3.74 \text{ in}^2) / (24" \times 0.40") \times 100 = 61\%$$

-As-measured web thickness is approximately 0.40".

-Stringer S1 is a steel channel member. The bottom flange of the channel member is located at the right side. The bottom flange exhibits 10"L x 3"W corrosion hole at the edge of the flange with 30% section loss surrounding hole followed by 20% section loss for full width of flange for 12"L. (Not shown in sketch since left face of stringer has full web height of curb stringer with readings taken at left face)

Point A:  $(0.40" - 0.12") / 0.40" = 70\%$ Point B:  $(0.40" - 0.18") / 0.40" = 55\%$ Point C:  $(0.40" - 0.25") / 0.40" = 38\%$ Average Section loss:  $(70\% + 55\% + 38\%) / 3 = 54\%$

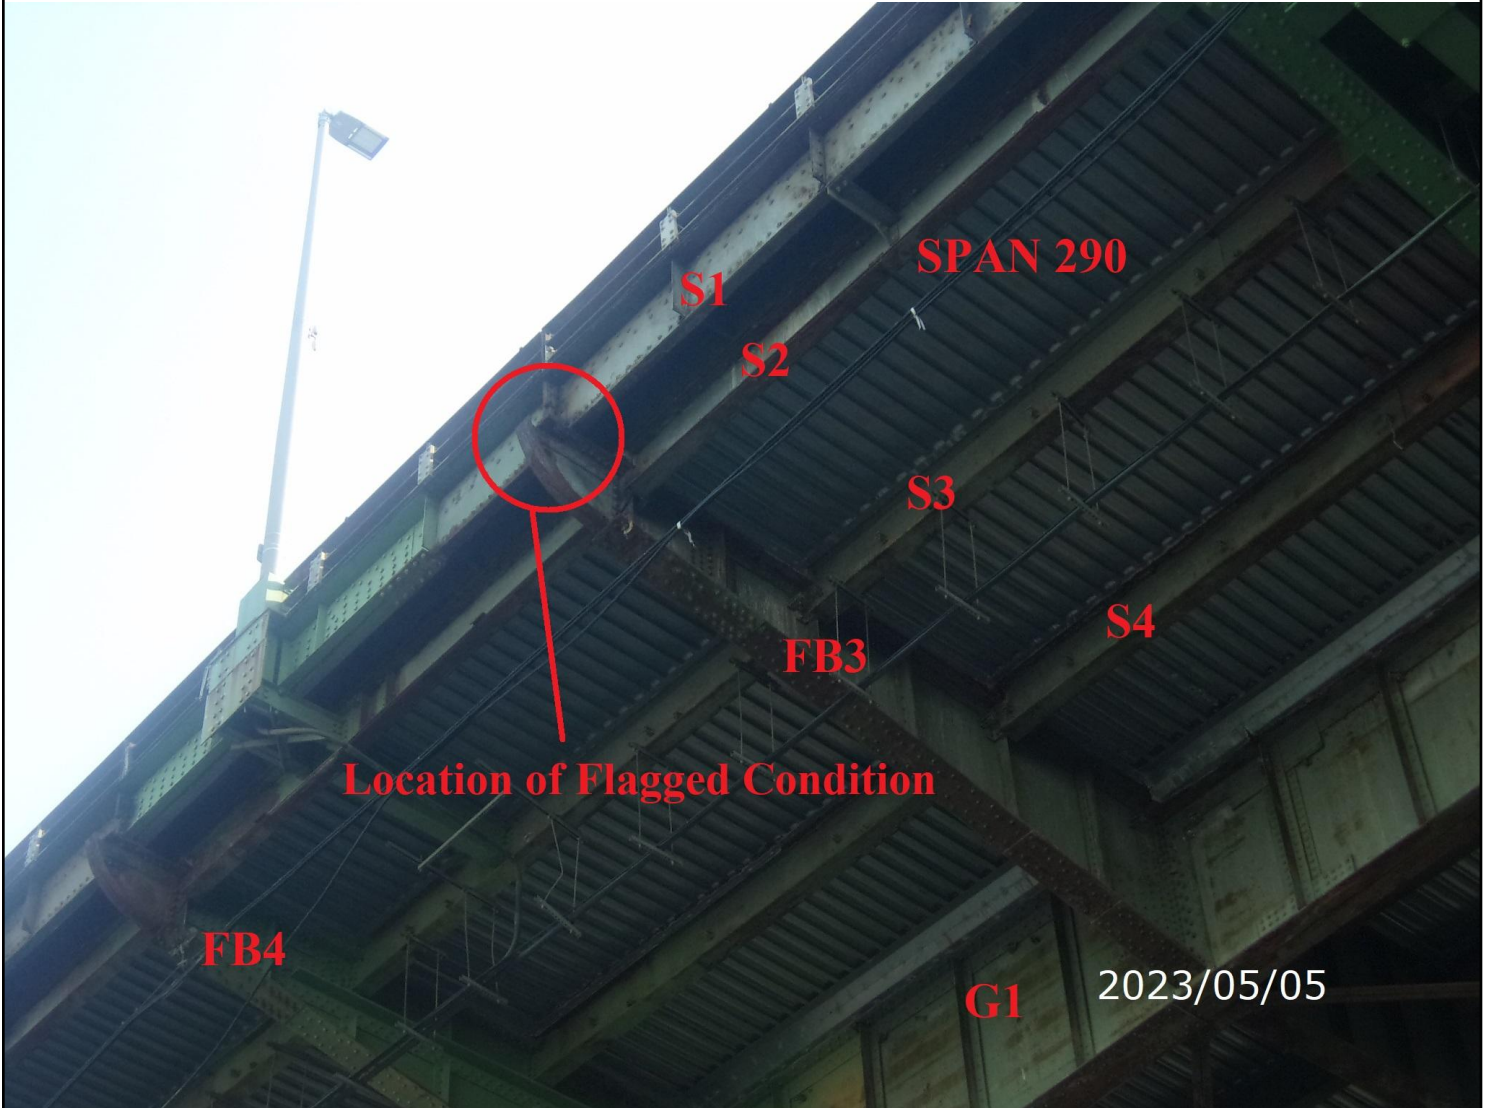
Photo Number: 3

**Attachment Description:** General view of the flagged condition at Stringer S1 on the end side of Floorbeam FB3 in Span 290. Looking End and Right.

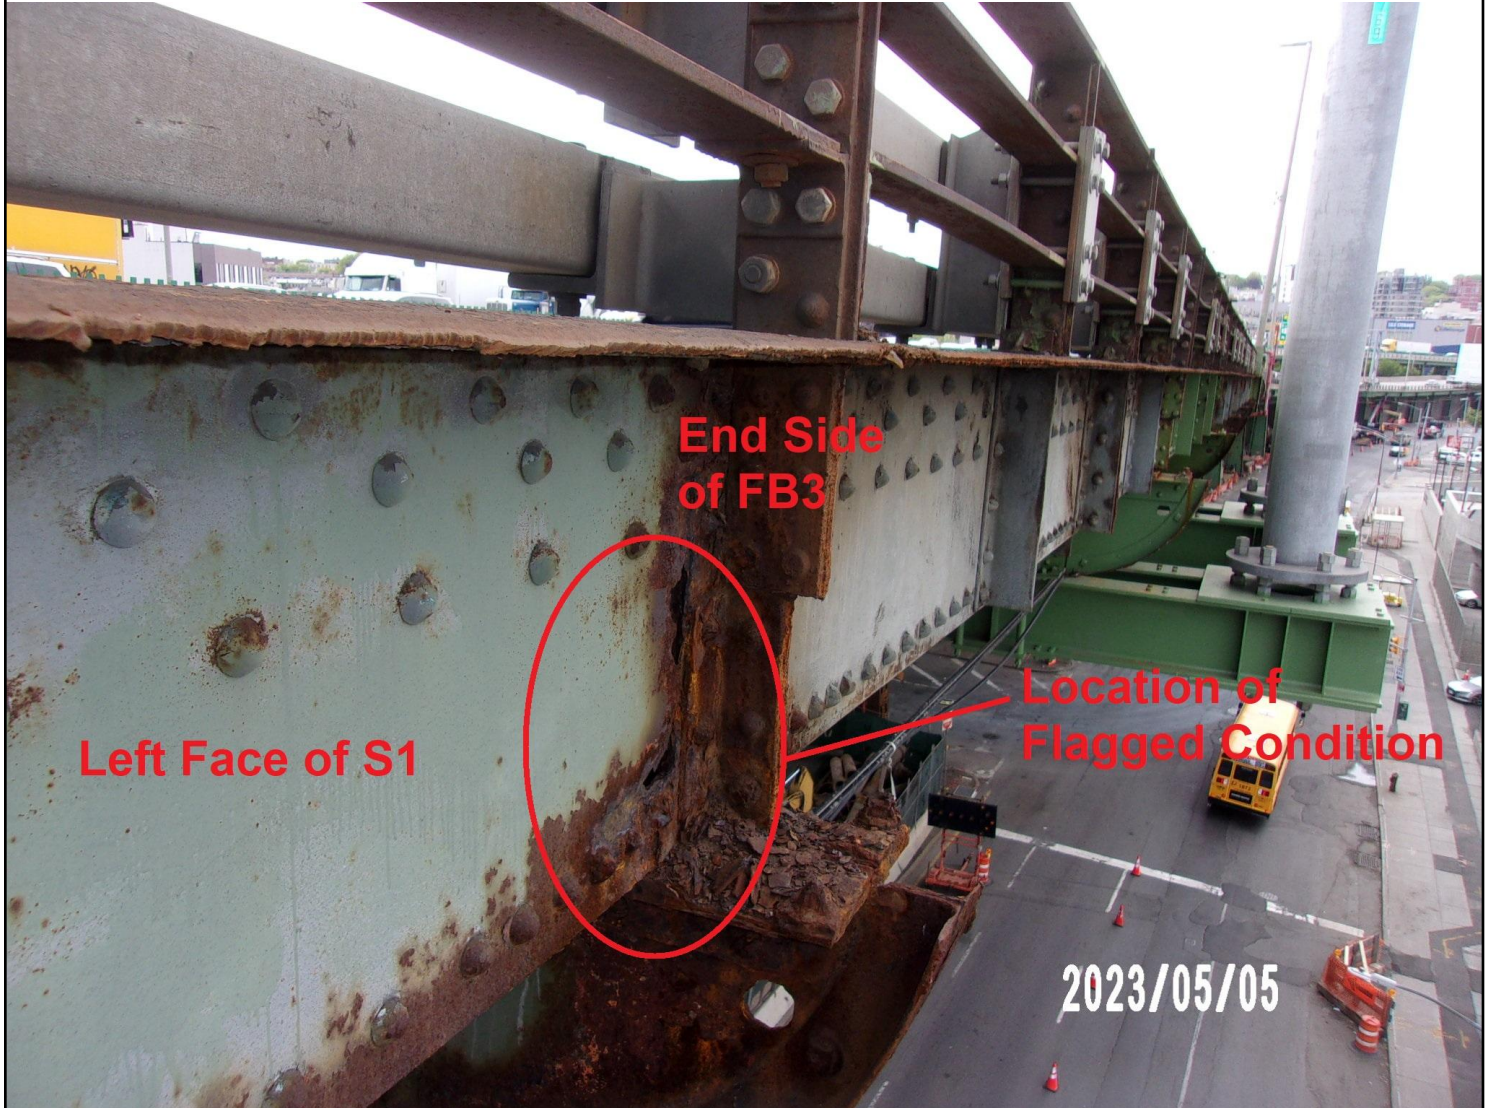
Photo Number: 4

**Attachment Description:** Close up general view of the flagged condition at Stringer S1 on the end side of Floorbeam FB3 in Span 290. Looking Begin and Right.

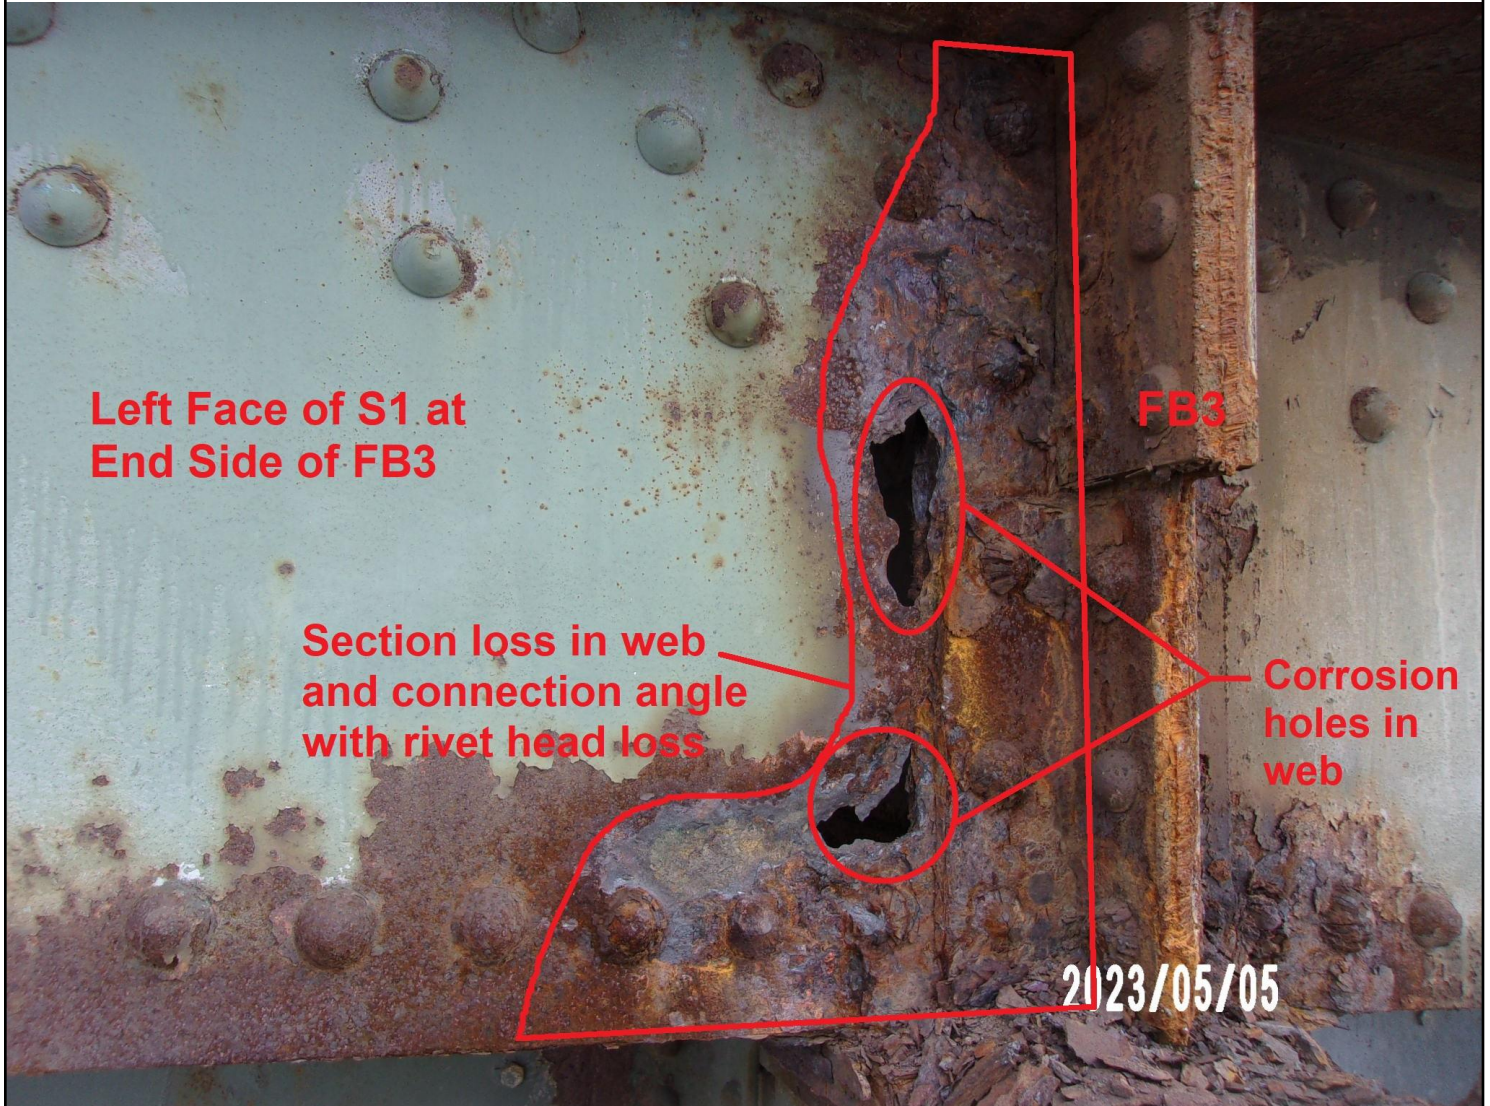
Photo Number: 5

**Attachment Description:** The left face of Stringer S1 at the end side of Floorbeam FB3 in Span 290. The stringer exhibits severe section loss with two corrosion holes in the web with rivet head loss in the upper and lower web. Also, the connection angle exhibits section loss for the full height with bolt loss. Looking Right.

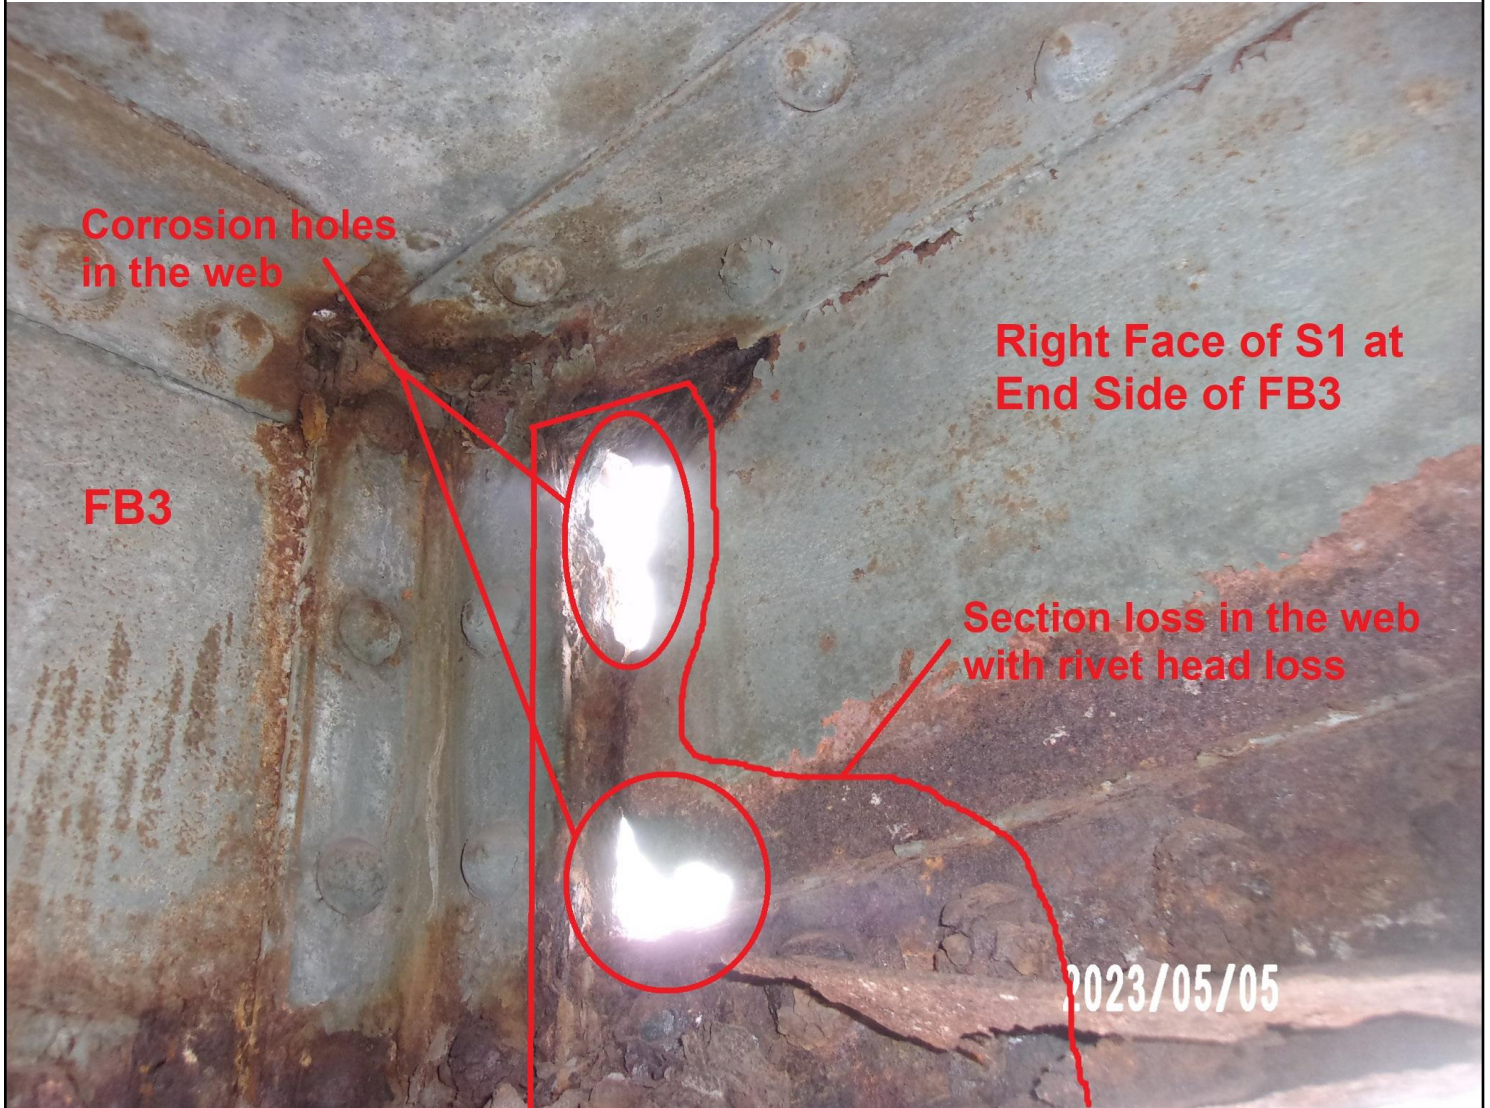
Photo Number: 6

**Attachment Description:** The right face of Stringer S1 at the end side of Floorbeam FB3 in Span 290. The stringer exhibits severe section loss with two corrosion holes in the web with rivet head loss in the lower web. Looking Begin and Left.

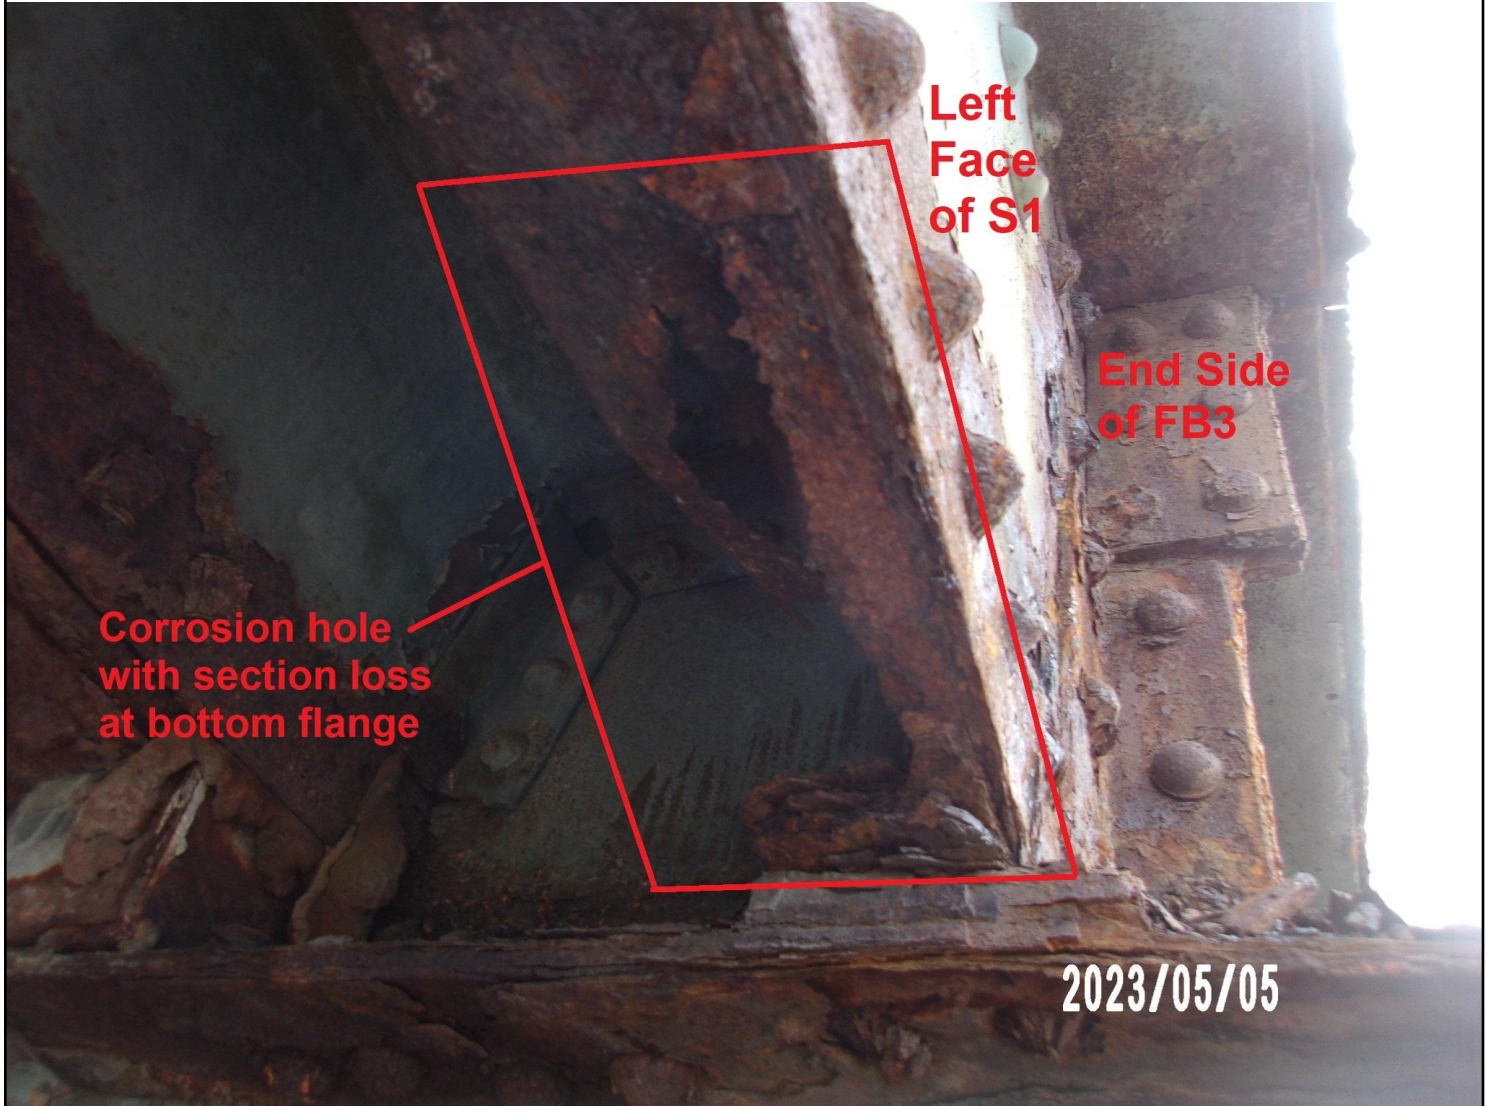
Photo Number: 7

**Attachment Description:** The bottom of Stringer S1 at the end side of Floorbeam FB3 in Span 290. The right side bottom flange exhibits corrosion hole at the edge with section loss surrounding the hole. Looking Begin.
